Nuclear Decontamination

EnviroCare of Utah
Salt Lake City, Utah
Clive Facility
July 2001

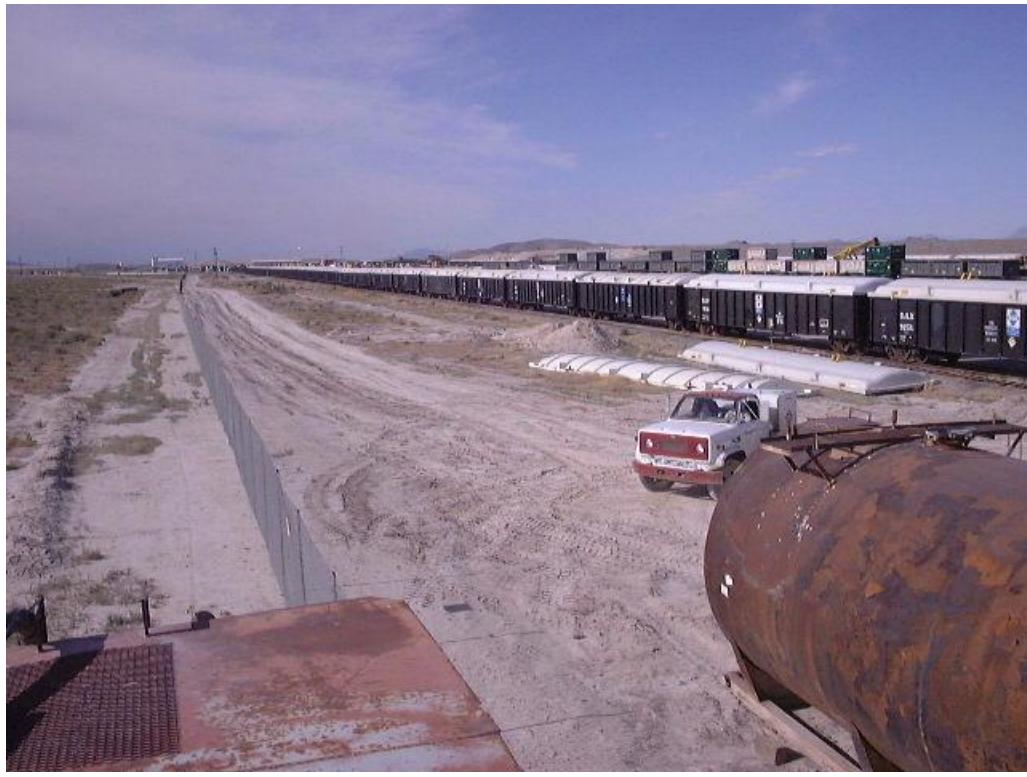
Picture 2: 150 Gondola type rail cars ready for decon and RTS.

Customer has 150 gondola type rails cars used to transport contaminated soil/debris to it's facility in the Tooele Hazardous Industry District.

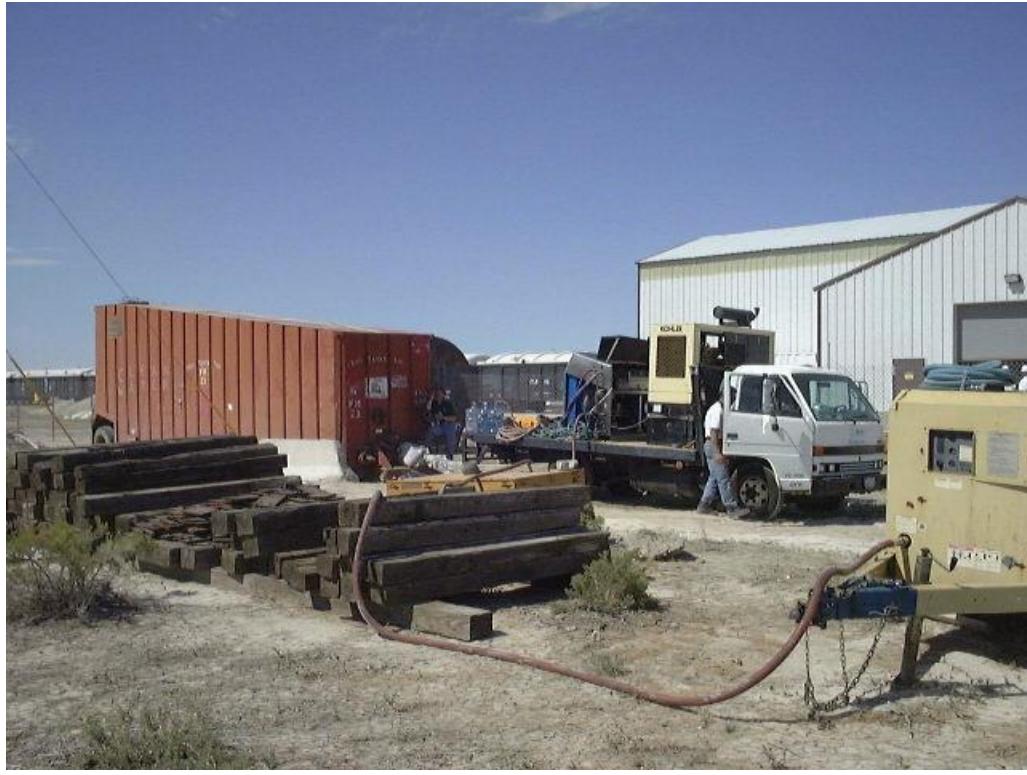
Picture 4: Mobile ice blast system inside buffer zone.

Customer requires CIB to provide a completely portable/mobile equipment/set-up so that the system can be operated outside the "restricted area" and inside the "buffer zone". The actual test cleaning is performed by the customers prime maintenance contractor inside the "New Rail Wash Station" facility, a controlled and restricted access area.

CIB supplied and set-up a complete mobile ice blast system on the desert floor for the customer to perform test-cleaning/decontamination evaluation. The ice blast system ran for approximately 5 hours during the testing phases. The system was stopped and started several times so the customer could perform sample testing. The ice blast system performed within normal operating parameters even though the operating environment exceeded optimal operating conditions.

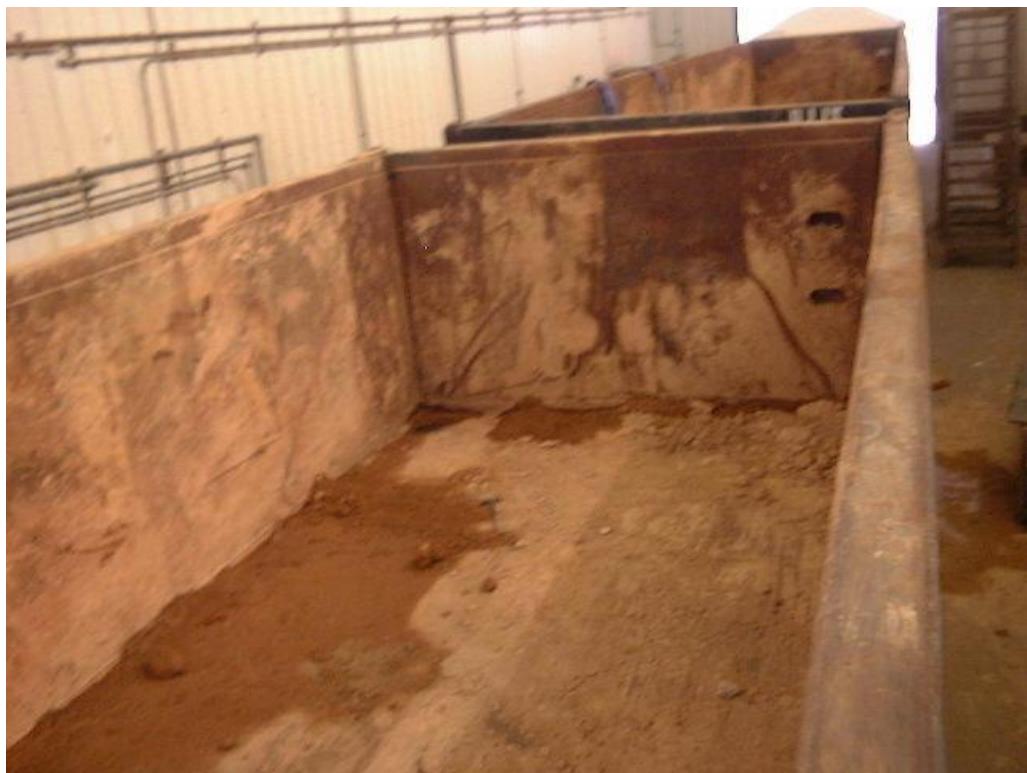
Picture 5: Rail car prior to ice blast.

Customer requested CIB demonstrate/test the ice blast process effectiveness in removing contaminated soil/dirt/debris from interior steel surfaces of transport rails car.

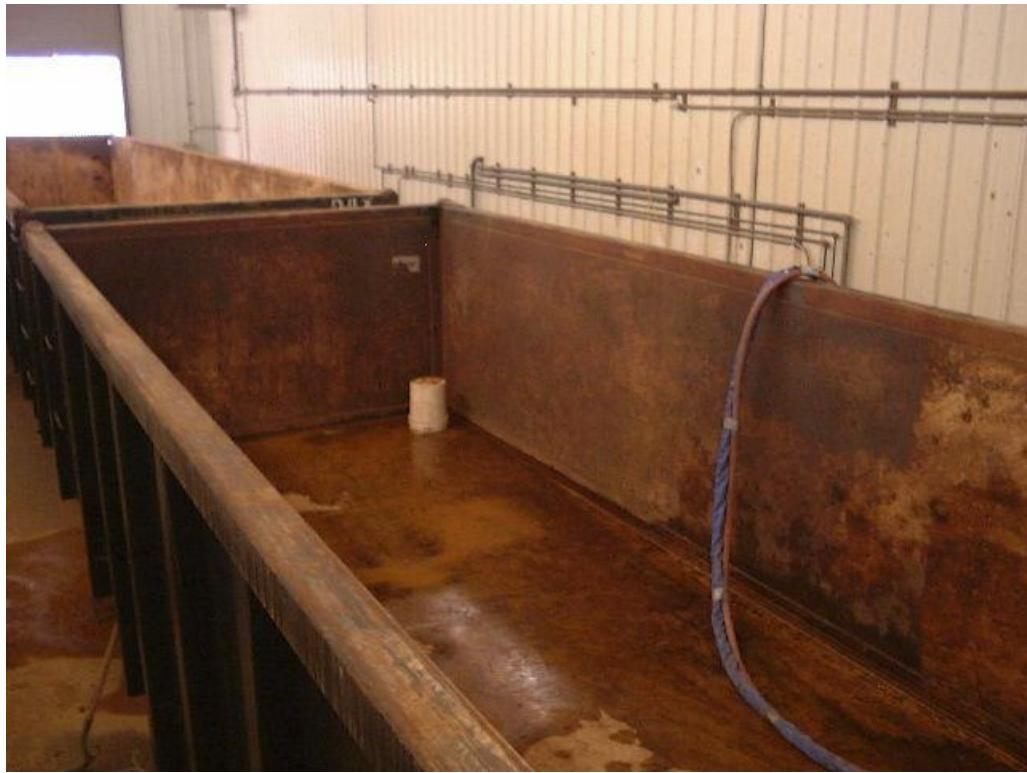
Picture 6: Rail car after ice blast..

The first test was to clean a square meter area and check for surface contamination residue. The customer spent approximately 10 minutes cleaning the 1 square meter area. A meter was used to check for background contamination and then a smear sample was taken to the customer's lab for analysis. Results showed the ice blast process was effective.

Subsequent test cleaning revealed the entire surfaces of the rail car could be cleaned in approximately 6 hours elapsed time or 18 man-hours (customer employed 1 man to operate the blast nozzle, 1 man to tend the ice/air delivery hose and 1 man to supervise the operation).
